## ILLINOIS ENVIRONMENTAL PROTECTION AGENCY

MEMORANDUM

DATE: November 19, 1982

SUBJECT: LPC #18302013 - VERMILION CO. - DANVILLE/DANVILLE PLATING

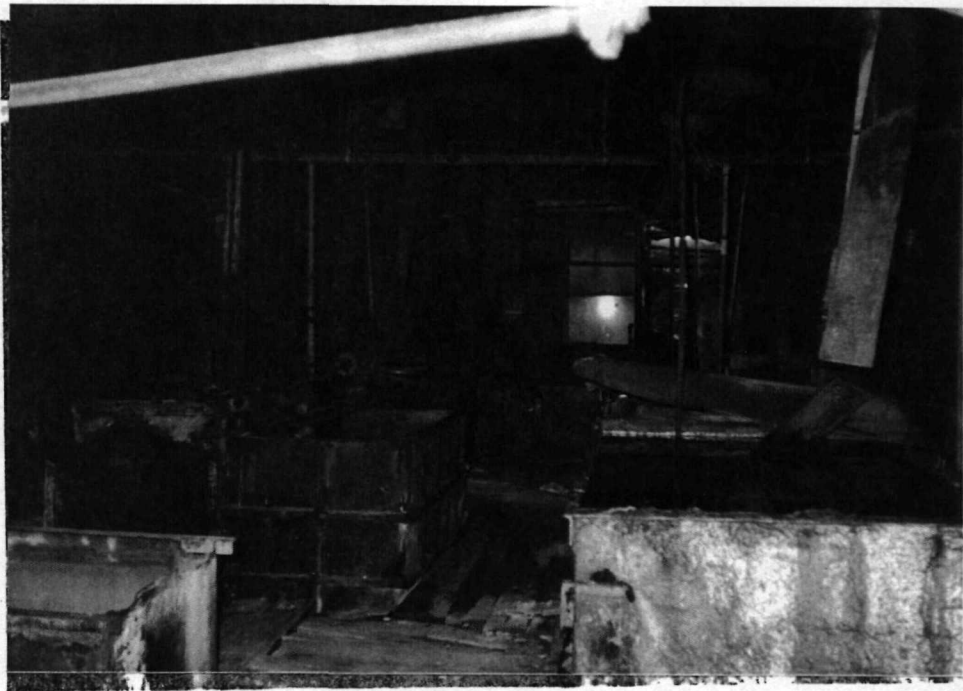
Comments: Photograph taken

toward the south from the  
north east part of  
Room 3

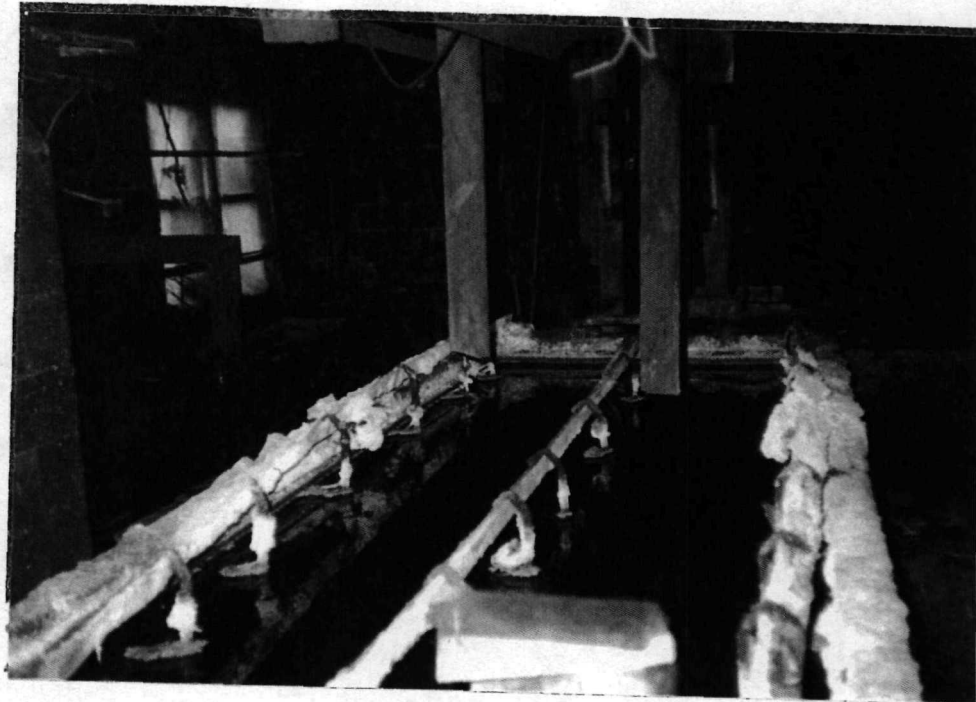
Comments: Photograph taken

toward the south from the

north central part of

Room 3

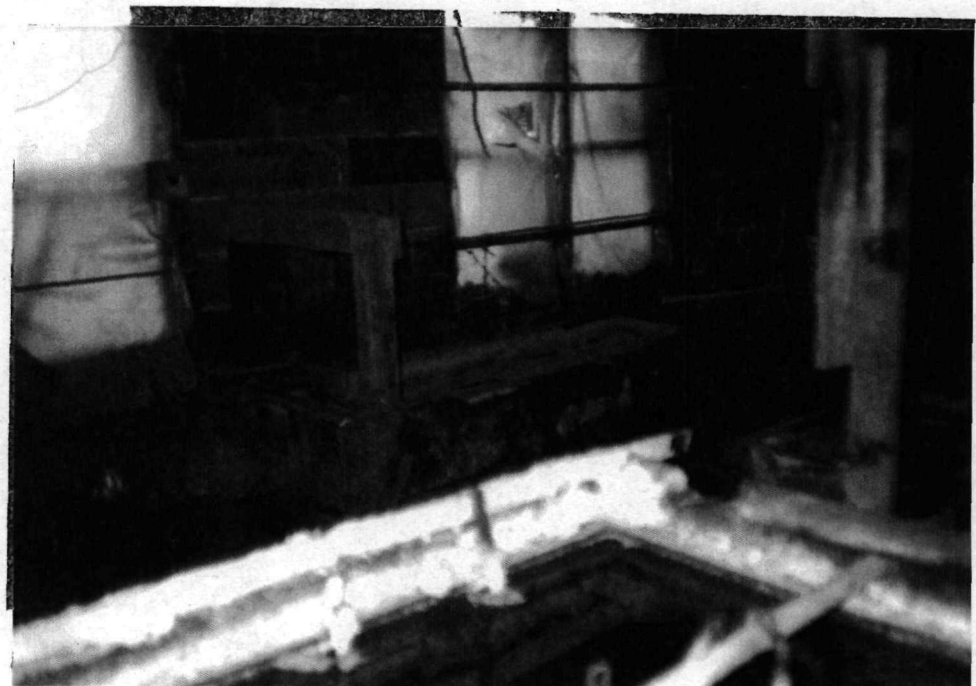
Comments: Photograph taken

toward the ~~north~~ south west

from the west central part

of Room 3

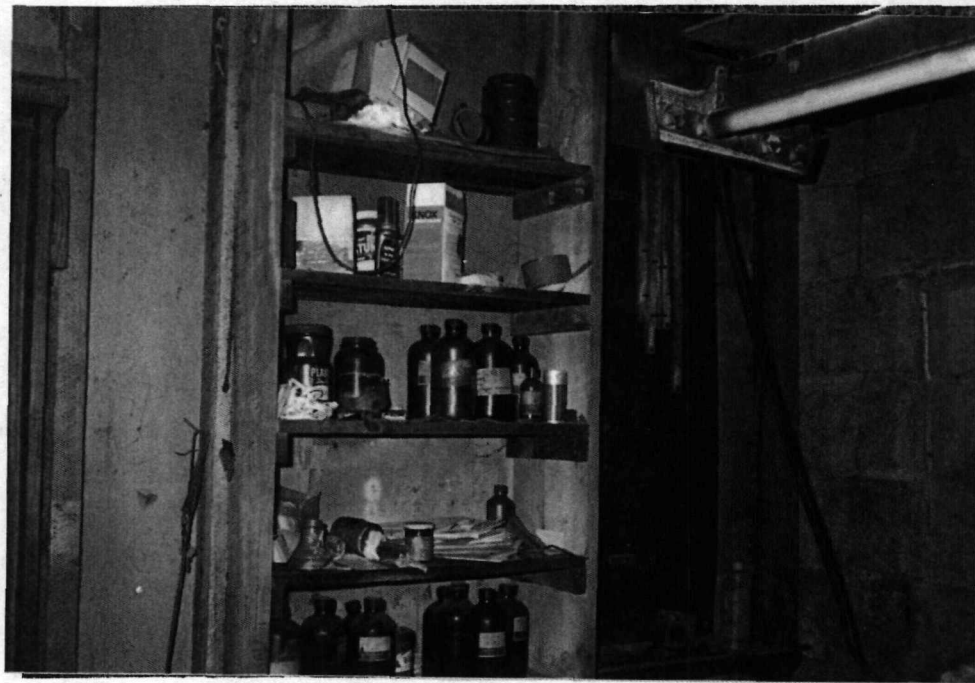
Comments: Photograph taken

toward the northwest from the  
central part of Room 5

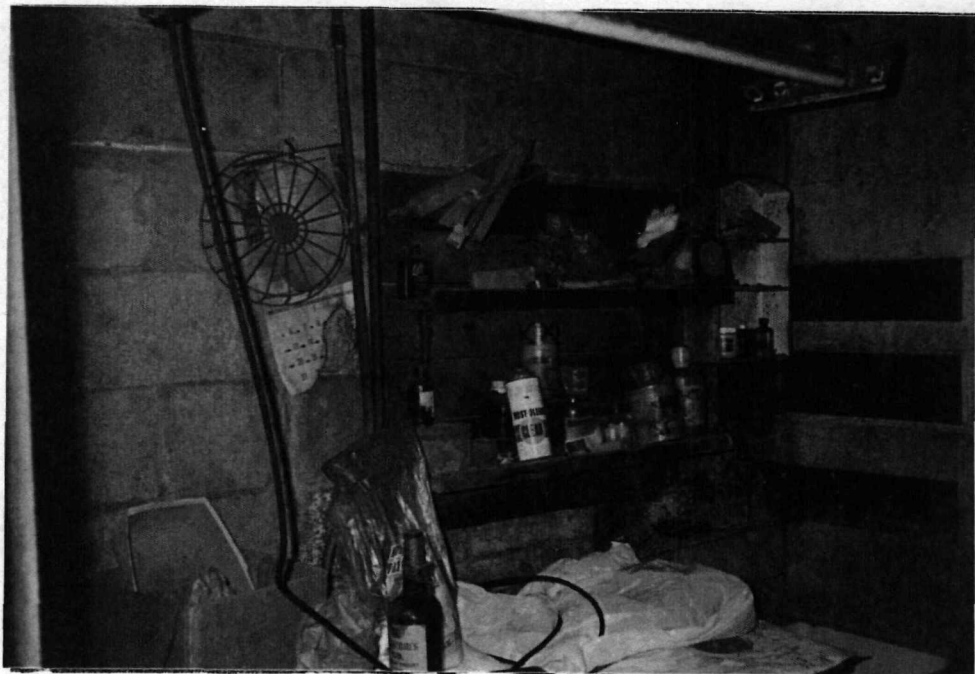
Comments: Photograph taken

toward the northeast from  
the central part of Room 5

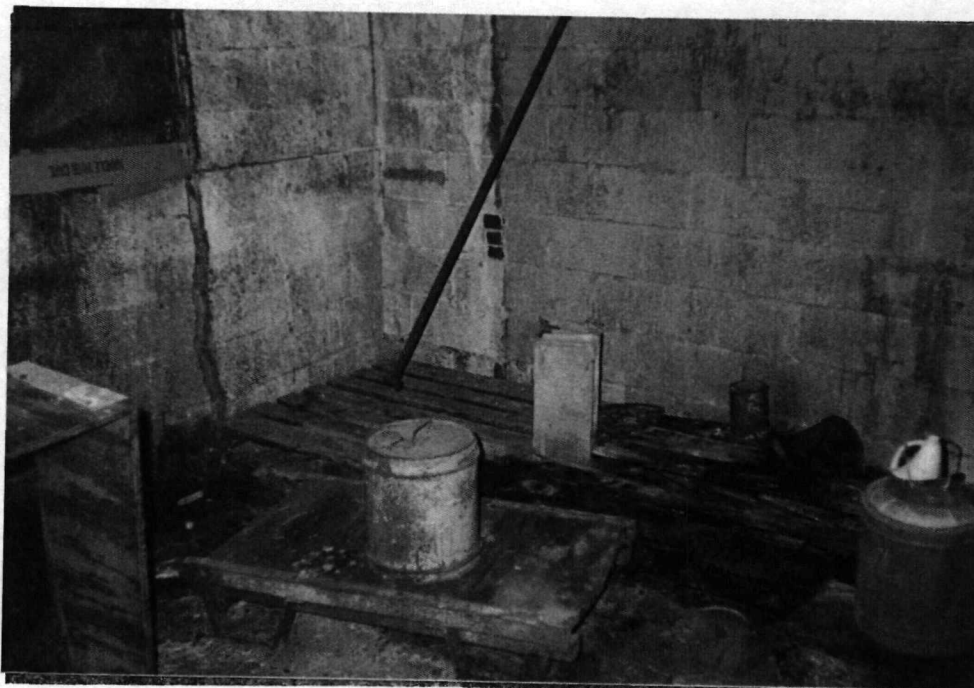
Comments: Photograph taken

toward the northwest from the

north central part of

Room 1

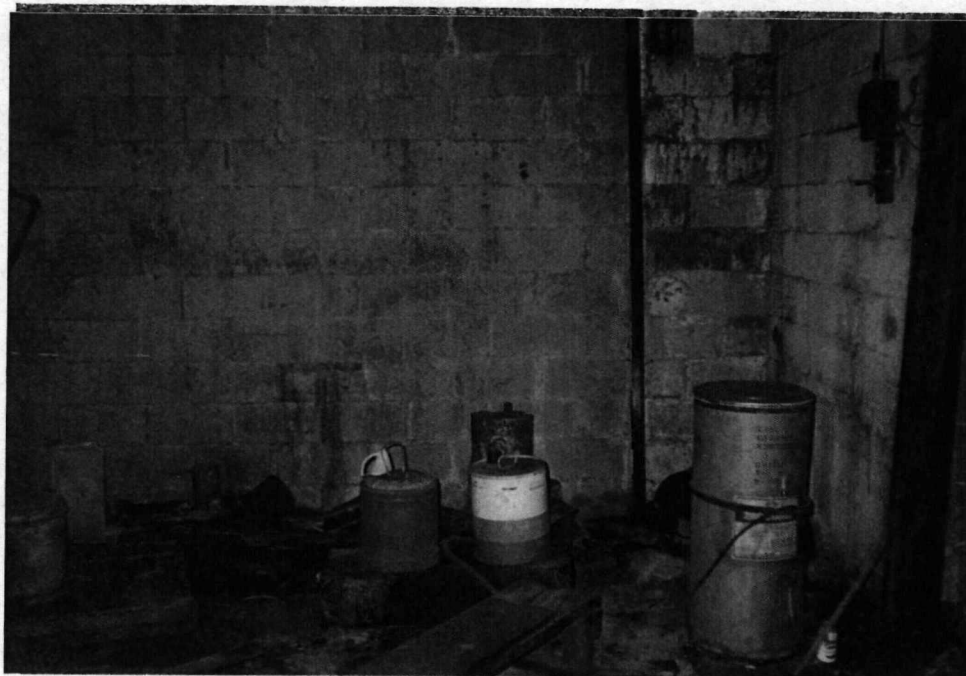
Comments: Photograph taken

toward the north from the

northeast part of room 1

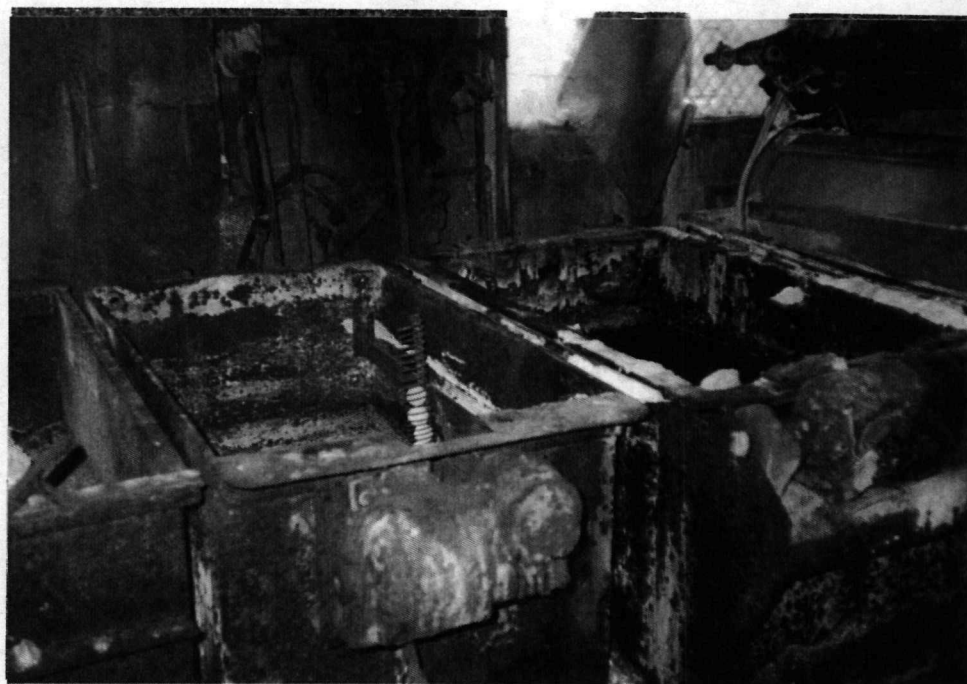
Comments: Photograph taken

toward the west from central  
part of room 1

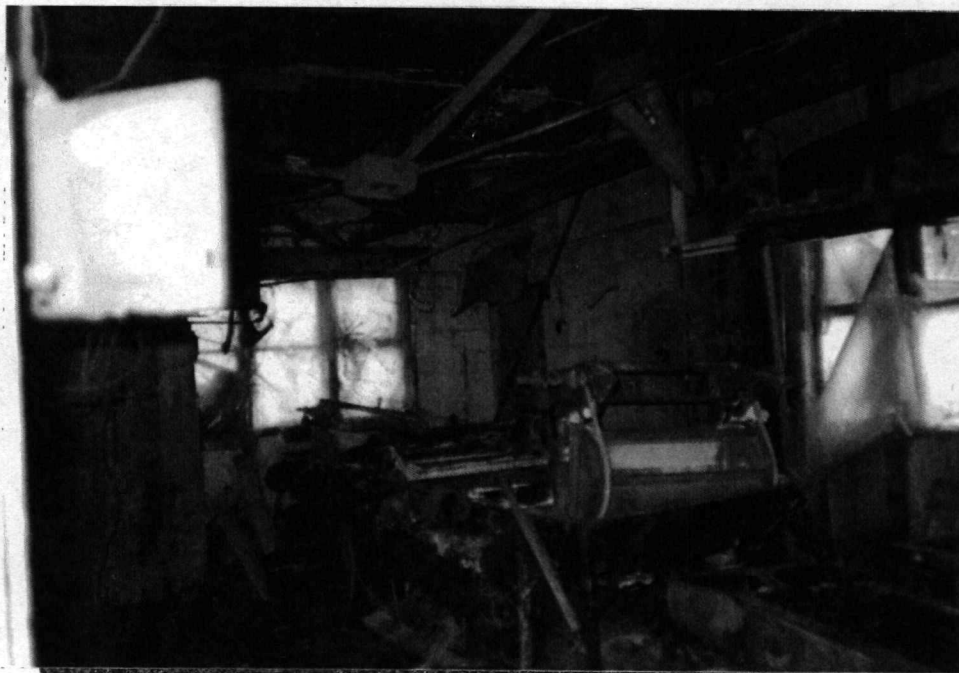
Comments: Photograph taken

toward the southwest from  
NE part of room 1

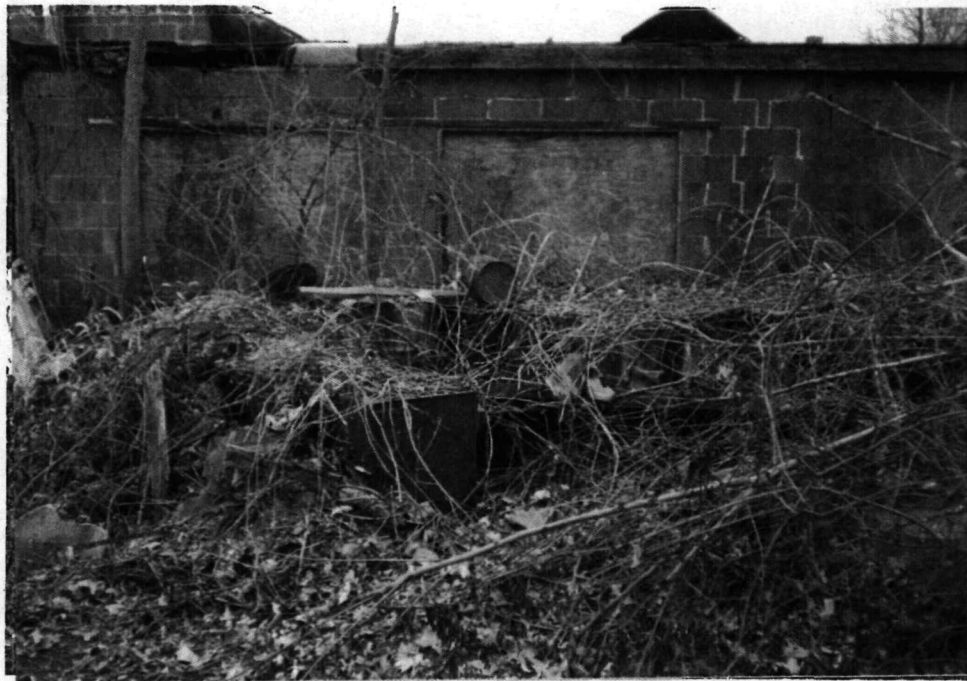
Approximately 20 drums were placed along the outer south-east wall. These were overgrown by brush and vines. They appeared to be in poor condition. On two of the drums, the tops had rusted through. Both contained a dark colored material. Field pH tests indicated that one had a pH of 7, and the other had a pH of 10.

Comments: Photograph taken

toward the north from the  
northeast

~~submerged~~ part of the

property

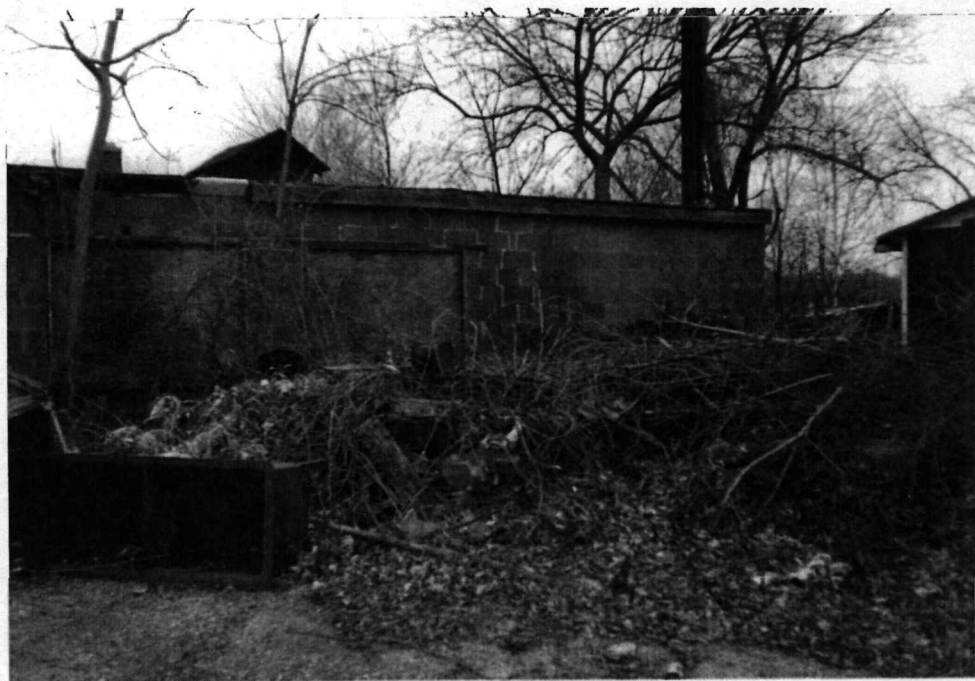
Comments: Photograph taken

toward the northeast from

the south central part of

the property

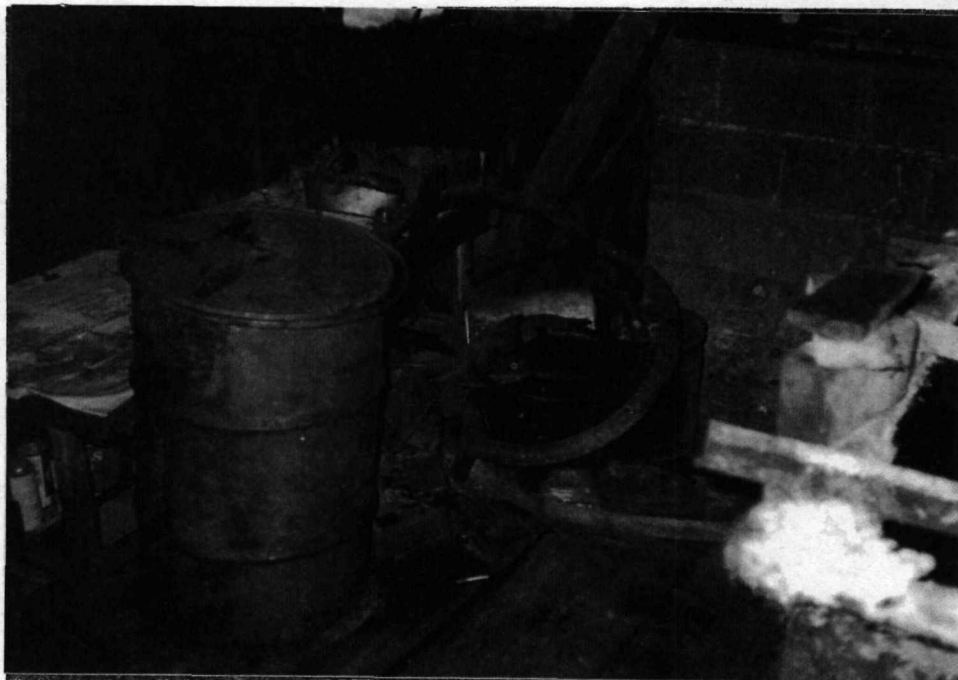
Comments: Photograph taken

toward the ~~south~~ northeast

from the northeast part  
of Room 3

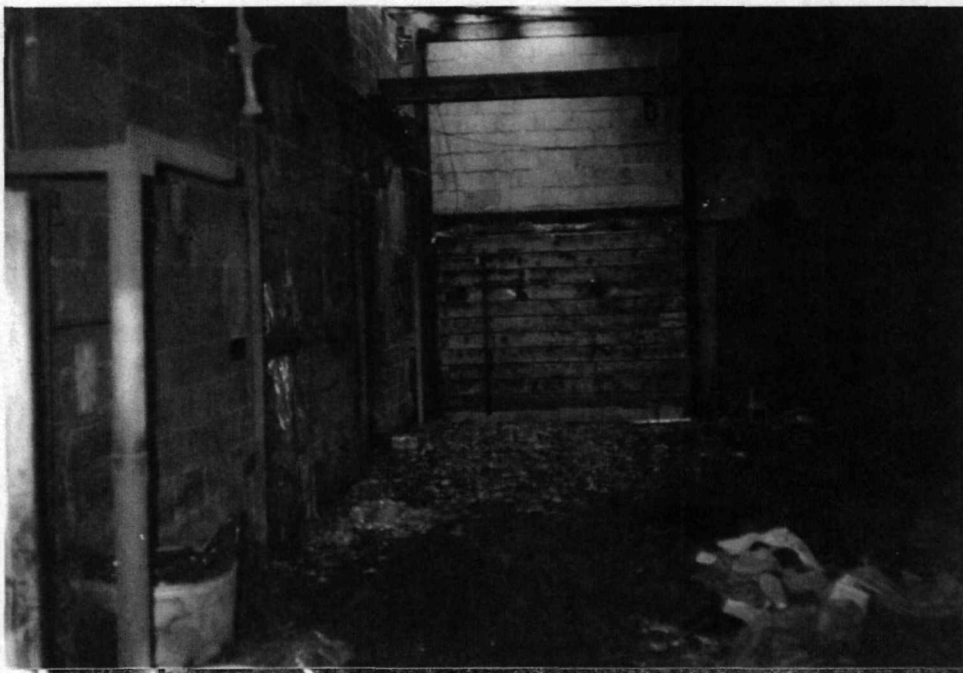
Comments: Photograph taken

toward the north from the

south central part of  
Room 2
